Amity Creek Restoration Initiative, Minnesota, USA:

Demonstration project to help restore and protect north shore Lake Superior Basin trout streams.

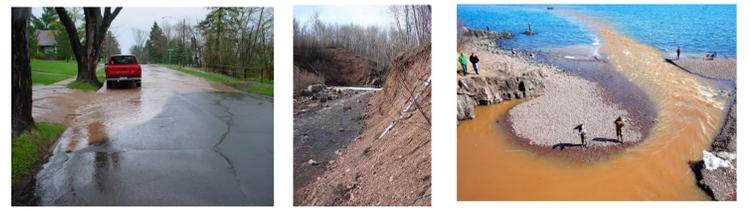
Sources of fine-grained sediment are thought to be from eroding stream banks, urban runoff, and increased peak flows. The LakeSuperiorStreams.org data viewer tool (left) shows the response of the creek to a rain event. Two days of rain (green bars) at the end of May 2006 led to very high flow (blue line) and turbid or muddy water (brown background). These data are from in-stream, continuous sensors that deliver data daily to the website. The figure on the right shows current stream turbidity data combined with the historical range bands to illustrate how the current data compares with the values from previous years for the same days.

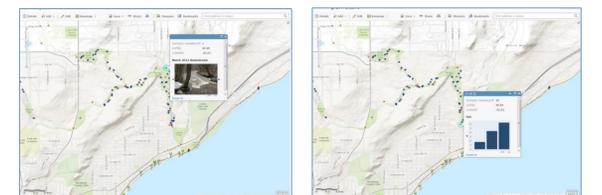
Several stream-wide surveys have also been conducted to help better understand the differences in water quality throughout the watershed. The left figure shows results of a synoptic survey just following snow-melt in 2011. The maps to right allow a user to view both data and images at each of the sampling locations.
