Seize the day: What to do when a 500-year flood strikes in your backyard

The Duluth, MN, area experienced massive flash flooding following 8-10 inches of rain in 24 hours in June 2012, causing extensive damage at Jay Cooke State Park. One affected site involved a levee breach on Forbay Lake, releasing a flood wave downslope, carving a deep valley and destroying part of Highway 210. Although devastating for the park, the event provided opportunities for student research and outreach. Students from two classes at the University of Minnesota Duluth (UMD) conducted research in October 2012 to reconstruct magnitude and timing of the flood wave, impoundment behind the road, breaching of the road, and subsequent incision. Student projects focused on delineating the flood wave's lateral extent; determining peak shear stress and its effect on sediment mobility; estimating volumes of material eroded from the levee and deposited in the temporary impoundment; and tracking knickpoint propagation. Graduate students in a fluvial geomorphology course were able to address more complex issues including paleoflood discharge, levee geotechnical stability, and detailed long profile development. Collec

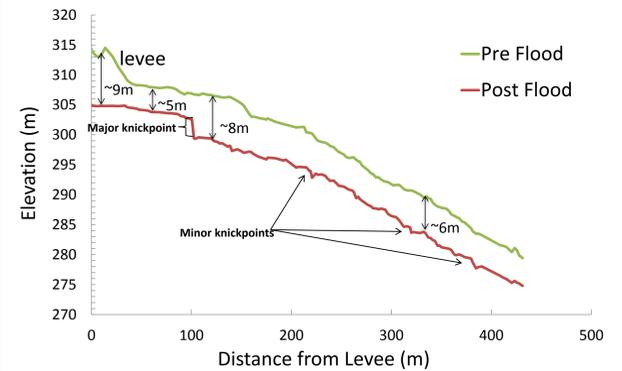
(1) Students surveyed the long profile of the channel downstream from the levee breach with a total station and compared the long profile to a pre-flood profile using lidar data from Spring 2011.

Long profile of incised channel downstream of the levee, compared with pre-flood lidar elevation data, by Grant Neitzel.

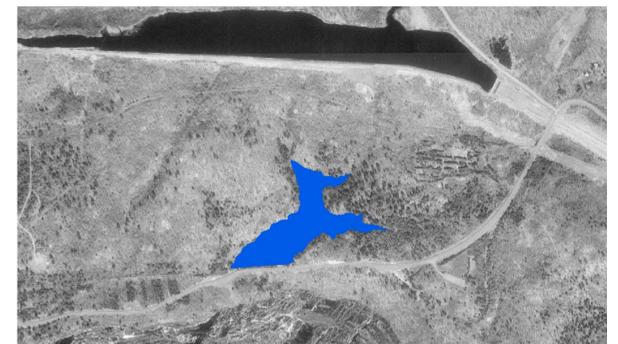
(2) Students used a GPS to mark the edges of the lake impounded behind the road, and estimated the volume of water held there temporarily. An extension of this was to determine potential discharge rates when the road failed.

Map of impoundment created behind road, by Michael Harris.

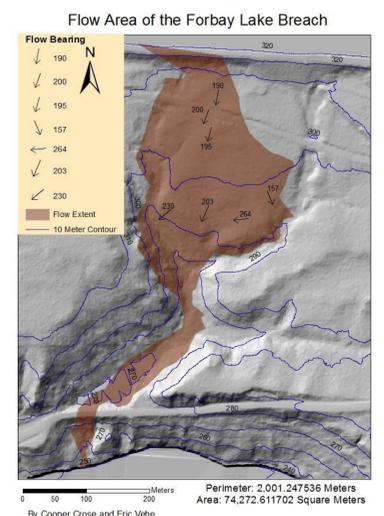
(3) Students mapped the extent of the flood wave with a handheld GPS. They used debris caught in trees as flow directional markers to capture the dynamics of the flow.

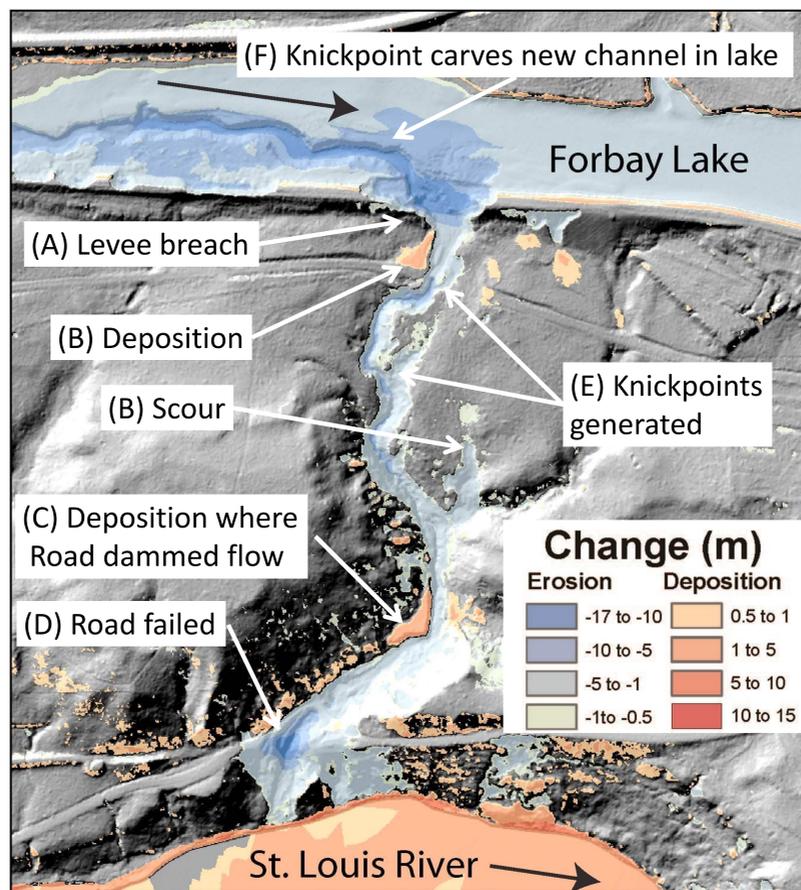
(F) Meanwhile, a knickpoint generated at the levee breach site itself moved upstream over 500 m, carving a new channel up to 5.5 m deep.

Hillshade of Forbay Lake breach at Jay Cooke State Park, MN. Overlain on the hillshade are data from repeat aerial lidar showing the difference pre- and post-flood. Lidar data were flown in spring 2011 and November 2012.
