Monitoring the effectiveness of large wood at maintaining deep pool habitat... through a 500-year flood event

Ryan Birkemeier, Water Resources Science Graduate Program, Department of Bioproducts and Biosystems Engineering, University of Minnesota
Twin Cities, Email: birk0115@umn.edu

Karen B. Gran, Department of Geological Sciences, University of Minnesota Duluth, Email: kgran@d.umn.edu

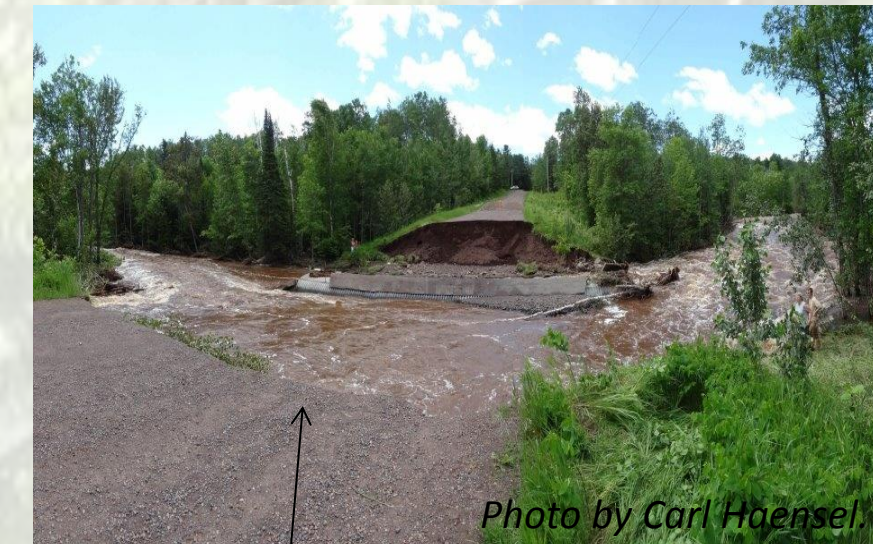
The main gage on the Sucker River was destroyed when the bridge it was on was washed out. The Knife River gage nearby shows the quick rise and fall of the floodwaters. Initial estimates put the flood at an ~500-year event.

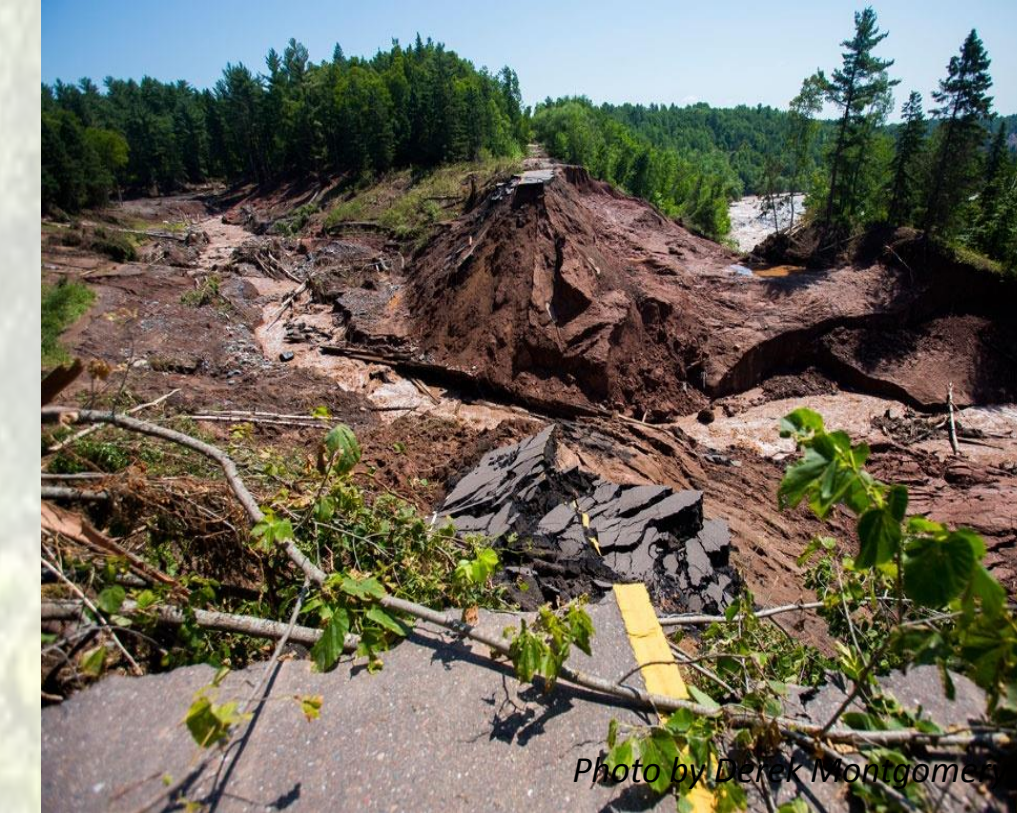
Flood damage at nearby Jay Cooke State Park. A dam breach on a canal led to excavation of a new channel.

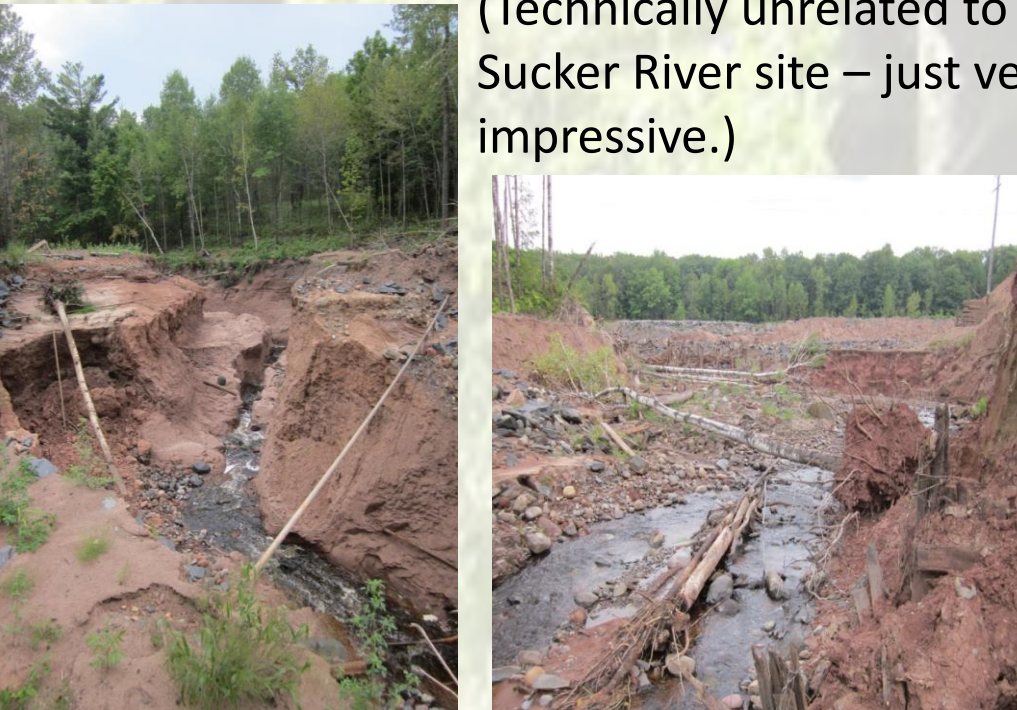
Looking downstream from breach

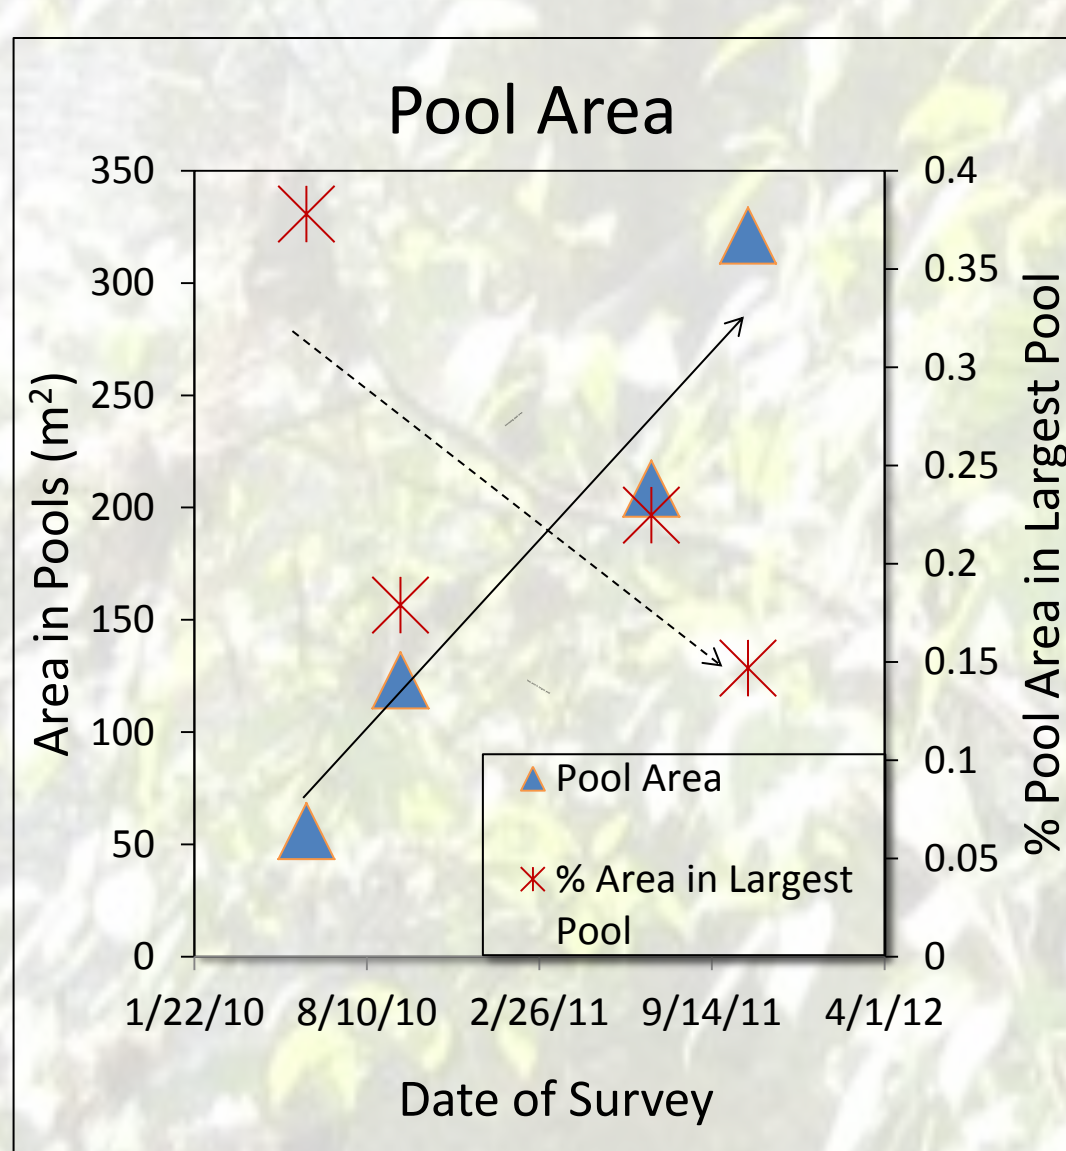
Area in pools (>0.6 m deep) increased from pre-project installation to post-project and has continued to increase over the last year. Care was taken to compare water depths between surveys with the 0.6 m cut-off shifted slightly to keep water depth for pools consistent.

The proportion of pool area found in the largest pool has also declined. There are now more pools with area in pools more evenly distributed.

Deep pool habitat was created, was being maintained, and was increasing through time. LWD continued to increase with captured logs.

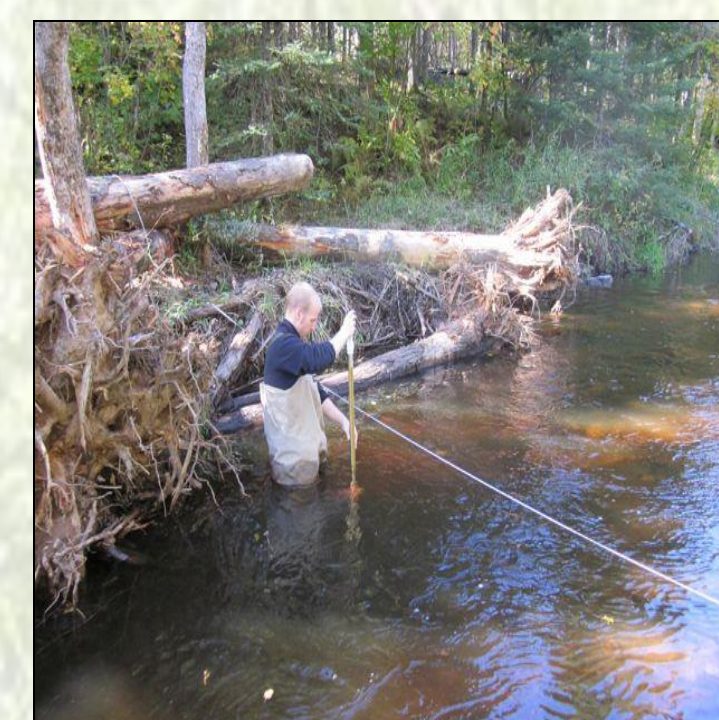
Installed log jams, Fall 2010.

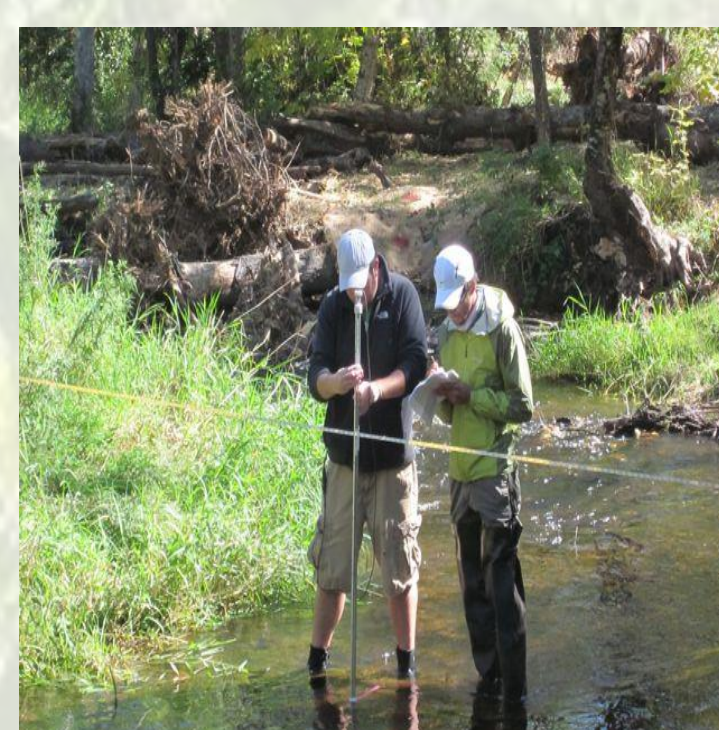
LWD pieces per 25m reach in 2009 (pre-project) and 2011 (post-installation). Most reaches showed an increase in the # of LWD pieces. Overall, the # of pieces almost doubled.

Total Pieces LWD:
2009: 50 (pre-installation)
2011: 91 (1 yr post-installation)

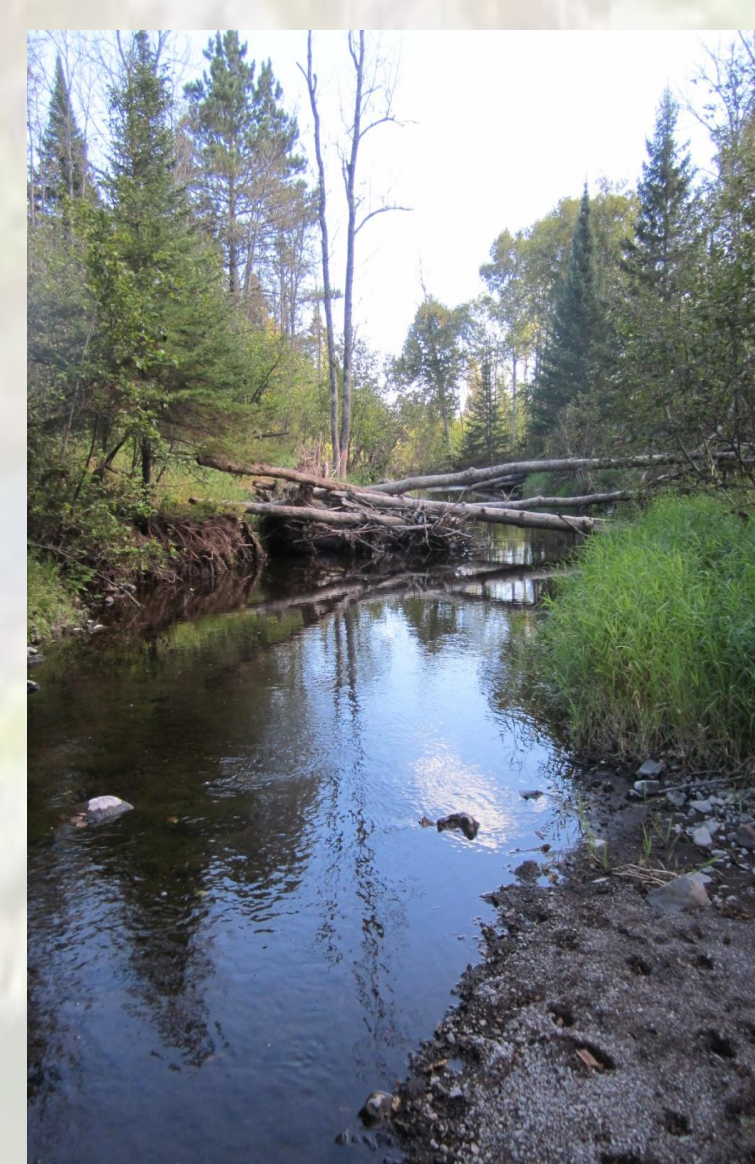
Over half of the pool area was found in a single large pool under a LWD jam that grew during the flood.

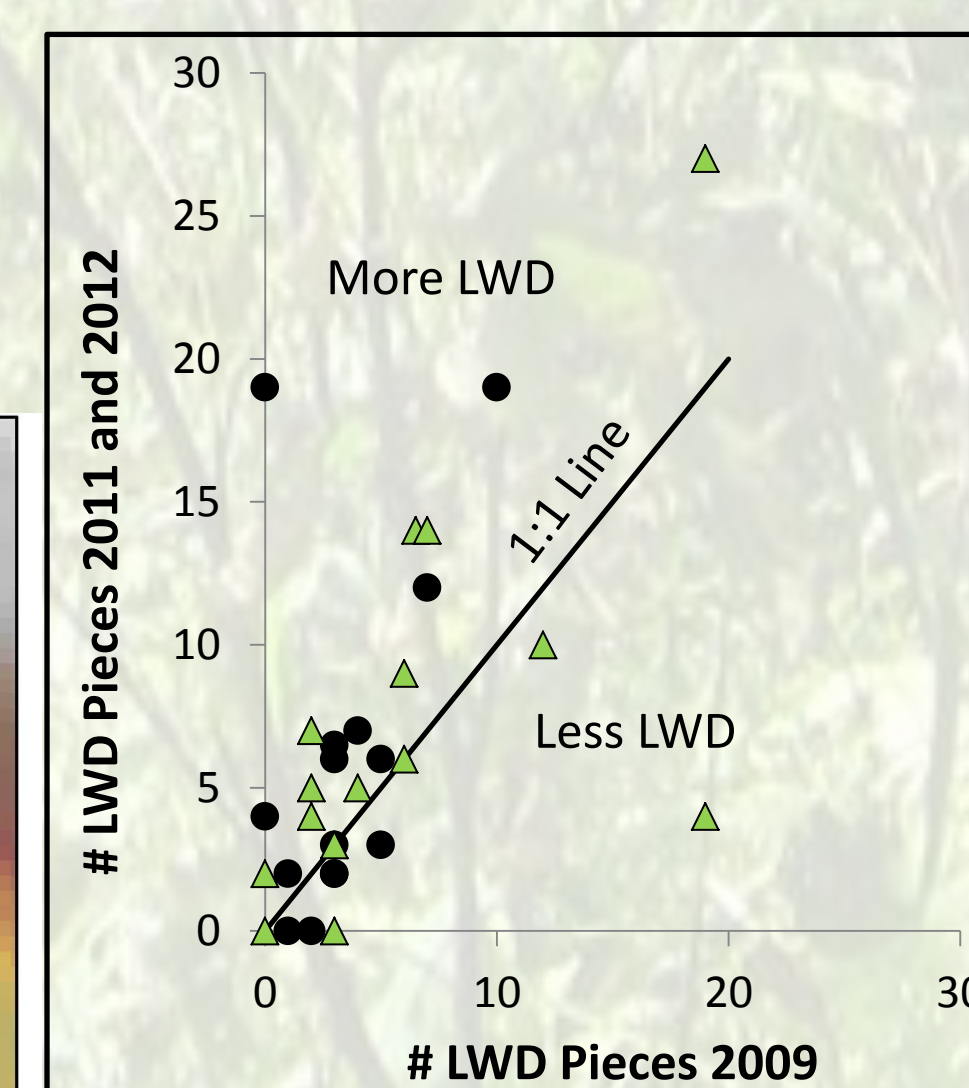
The amount of LWD stayed roughly the same. Many large, installed pieces were thrown into the floodplain and "lost" to the channel, but more LWD pieces were caught by existing jams.

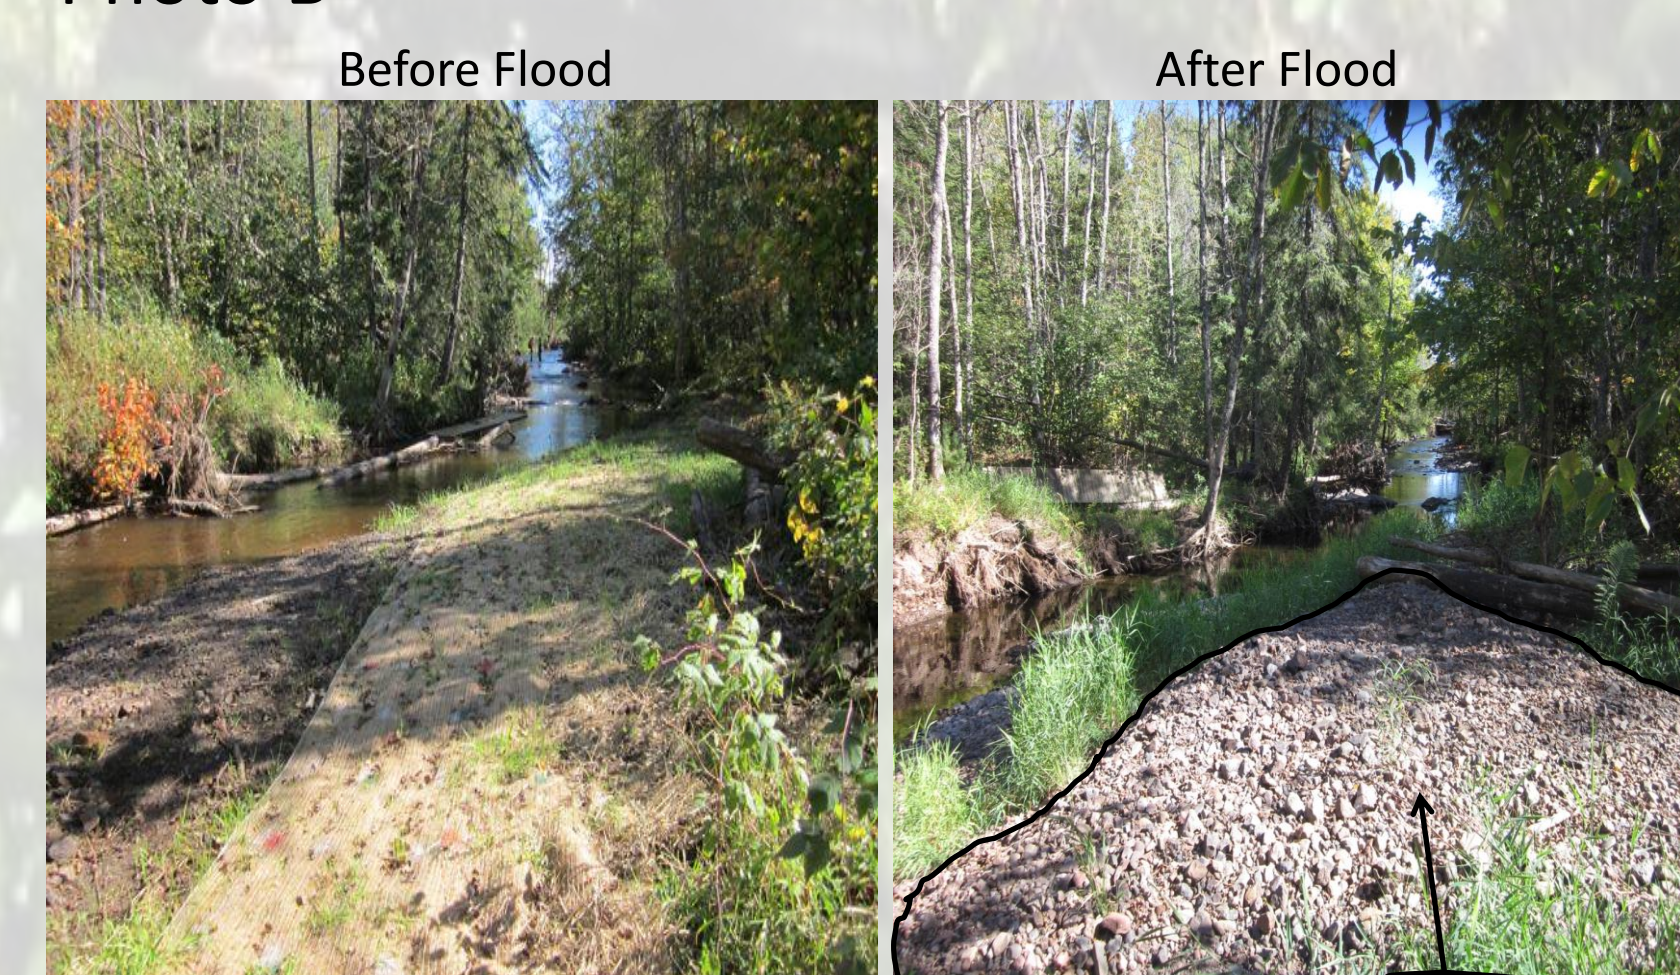
Photo B

> 1 meter of sand and gravel deposition
On the downstream end of the second bend, looking downstream. The downstream half of the reach experienced less erosion compared to upstream half, in part because much of the flow moved through the floodplain here. In the tight bends, significant deposition occurred on point bars.
